CONNECTICUT RIVER BASIN
PALMER, MASSACHUSETTS

DIAMOND INTERNATIONAL CORPORATION
UPPER DAM
MA 00562

**PHASE I INSPECTION REPORT
NATIONAL DAM INSPECTION PROGRAM**

OCTOBER 1980

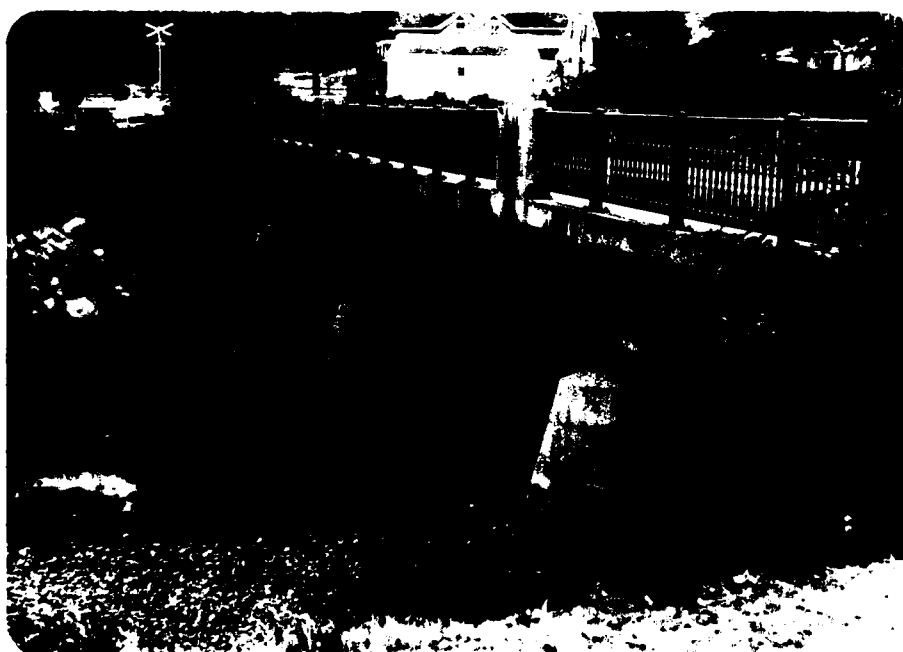
About 1,000 feet downstream of the dam, the Pleasant Street bridge spans the Ware River channel. Under normal conditions there is no restriction to flow of discharge from the spillway. Water flows under the bridge in three 12 to 14-foot high archways (see Photo No. 14).

**NO. 14 PLEASANT STREET BRIDGE OVER THE WARE
RIVER (DOWNSTREAM OF MAIN SPILLWAY)**
